**CAPITAL RESERVE ANALYSIS**  
FOR  
**BROOKSHADE**  
**MILTON, GEORGIA**

THE BROOKSHADE HOMEOWNERS ASSOCIATION, INC.

PREPARED BY: ROBERT "NICKO" N. ROMEO, R.S.

JUNE 2019  
REVISED: SEPTEMBER 2019

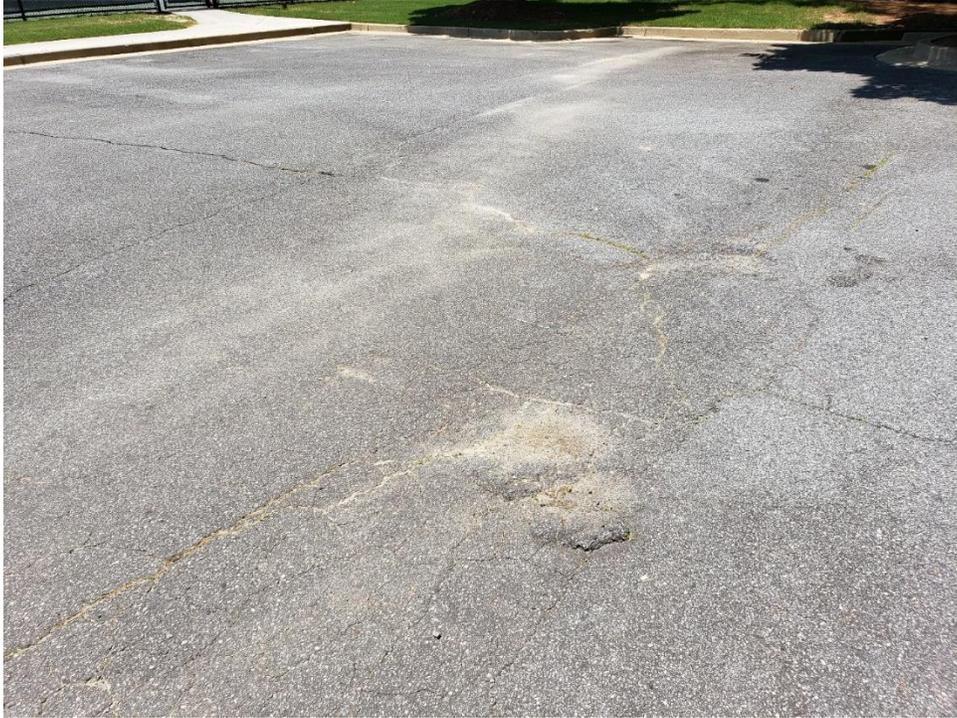
1. These items were found to be in good condition and well maintained. The useful life reflects the age and overall condition of the respective item.
2. **Parking Lot** – The parking lot at the amenity area appears to consist of a graded aggregate base, asphalt base course, and asphalt surface course. From our review, the asphalt pavement appeared to be in fair condition and experiencing normal wear and tear. It should be noted that we did observe multiple linear and “alligatored” cracks at sections of the asphalt (reference photographs 1 & 2). It is our understanding that the asphalt will be resurfaced in 2020 after the pool remediation is completed. The resurfacing of the asphalt should remediate all existing conditions at the parking lot if installed properly.

1. View of cracked and settled sections of the asphalt parking lot.

*In order to prolong the useful life of the asphalt pavement, we recommend that the cracks be filled and the pavement be sealcoated and striped every six to eight years. The useful life of asphalt pavement is approximately 20 years, after which, a new layer of asphalt should be installed. Prior to overlay, any settled areas should be removed, the base then re-compacted, and a new layer of asphalt course installed. It is recommended that a budget be allocated for the resurfacing of the asphalt with a 1-1/2" overlay every 20 years. We recommend that the asphalt surface be inspected approximately every ten years to determine if the condition of asphalt is adequate and if the useful life can be prolonged.*

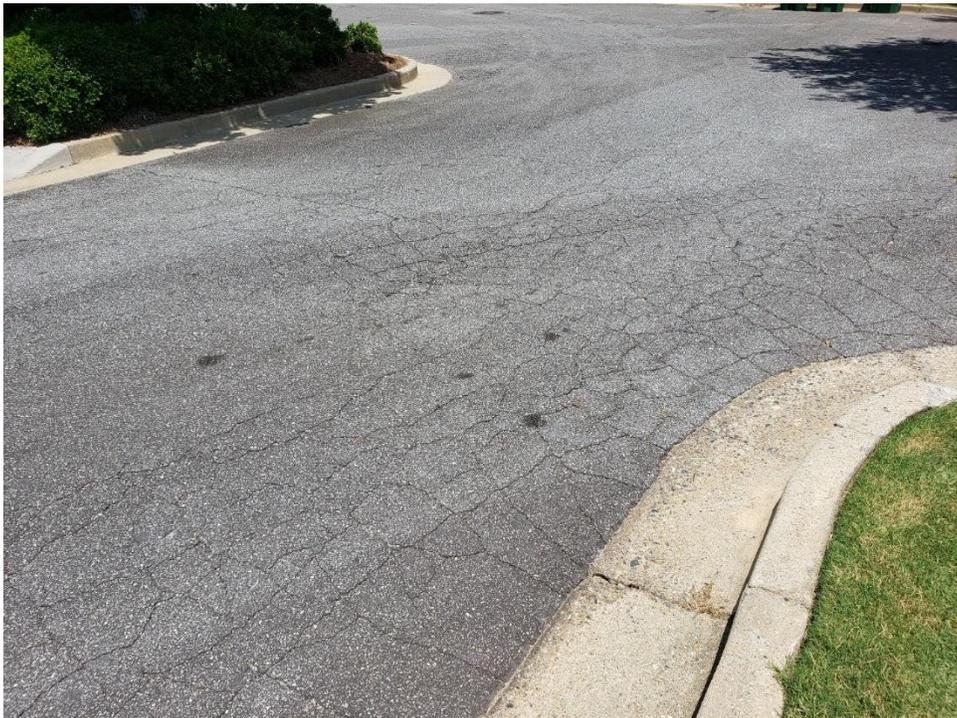
2. View typical "alligatored" cracks at the parking lot.

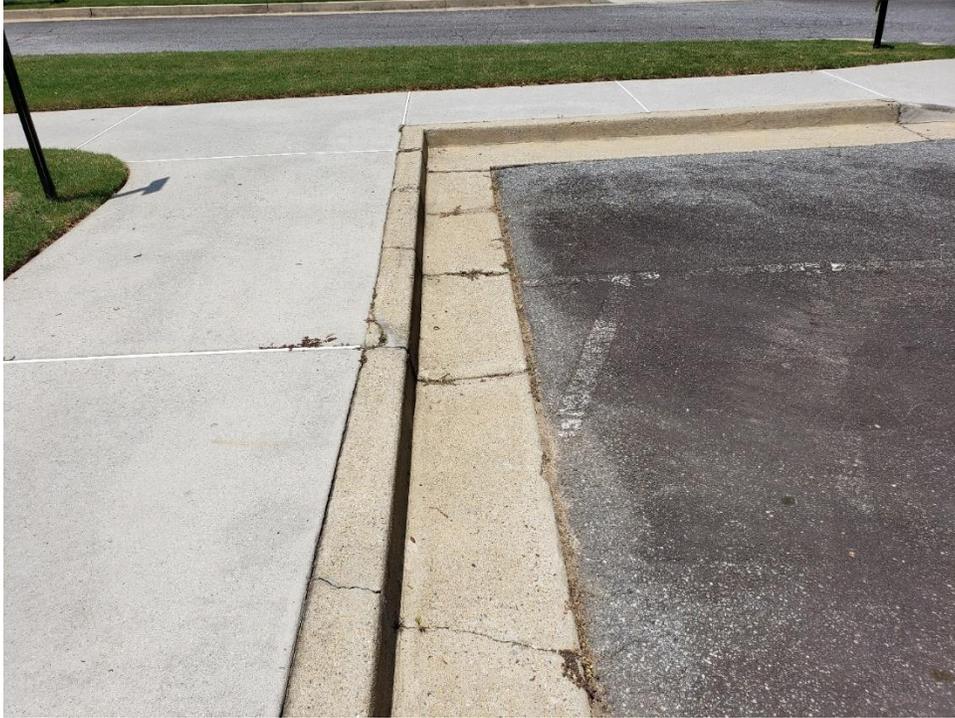
3. **Concrete Curb/Sidewalks** – The concrete curbs are located along the perimeter of the amenity area parking lot. From our review, the concrete curbs appeared to be in generally good condition; however, we did observe a few linear cracks and a section of the curb that is damaged (reference photographs 3 & 4). The sidewalks at the amenity area appeared to be in generally good condition with little to no cracks or settling observed; however, the section of the sidewalk at the beginning

3. View of typical cracks at a section of the concrete curb.

*Any sections of curb and sidewalks that are settling should be monitored, and if they continue to settle, these sections should be replaced. We have provided a budget for the replacement of damaged, deteriorated, or settled sections of the concrete curbs and sidewalk at the property. The budgets are provided every six years and the funding can be used when necessary, during the estimated useful life. The budgets are not for complete replacement of the concrete curbs or sidewalks, only replacement of the sections that become trip hazards or safety concerns. Any vertical displacement at cracks that could potentially represent a trip hazard and liability should be replaced. The curbs should be repaired or replaced when the asphalt is resurfaced.*

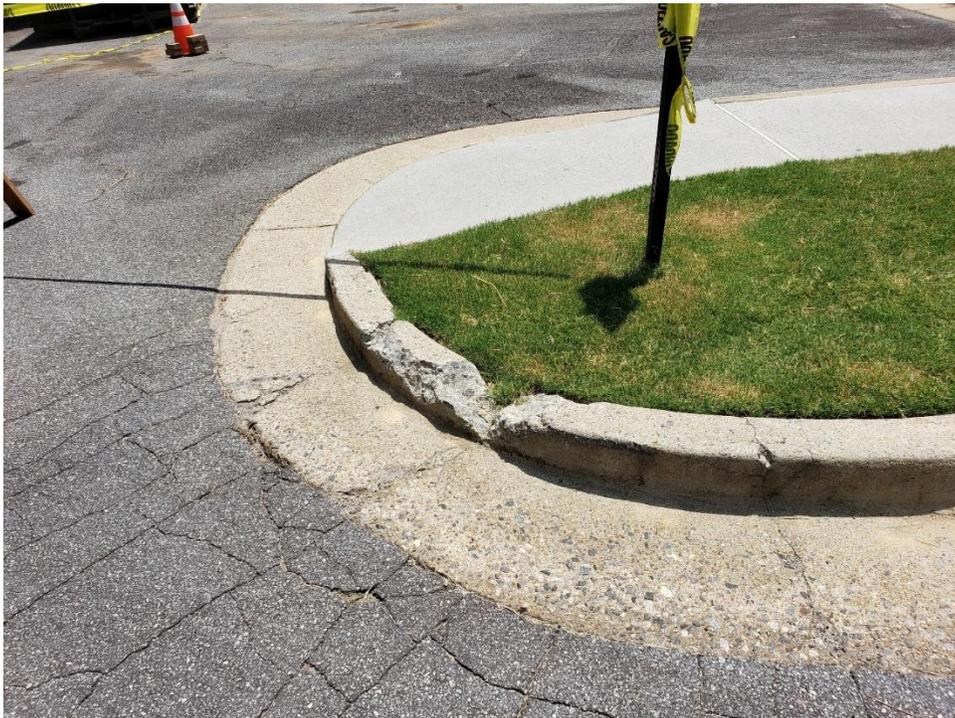
4. View of damaged section of the concrete curb.

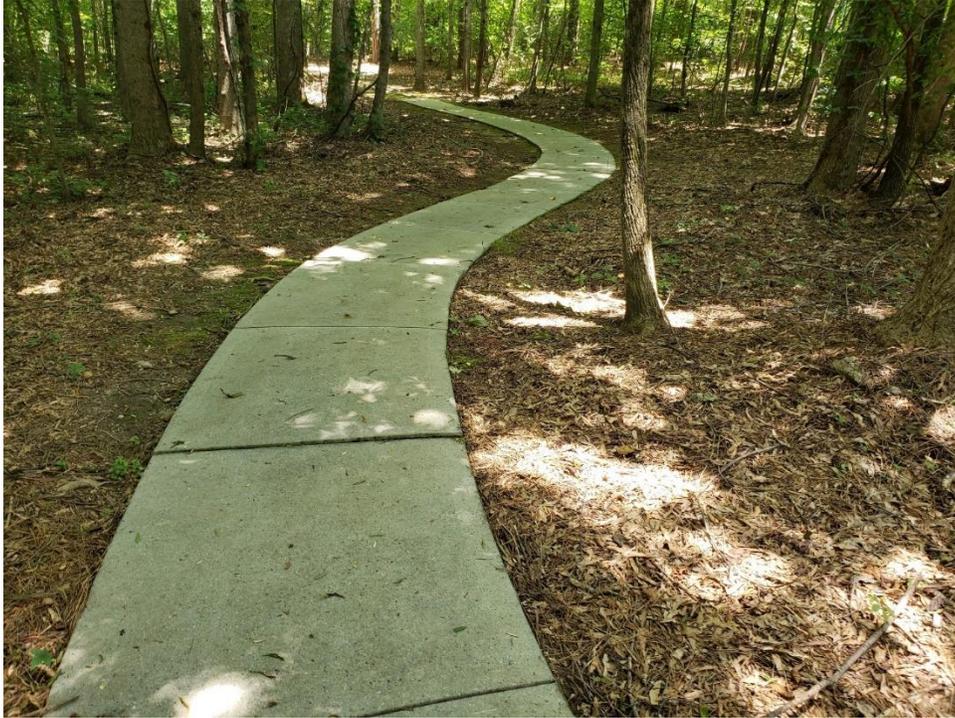
of the walking trail is uprooted by the nearby trees resulting in a potential trip hazard (reference photograph 5).

5. View of uprooted section of sidewalk at the walking trail.

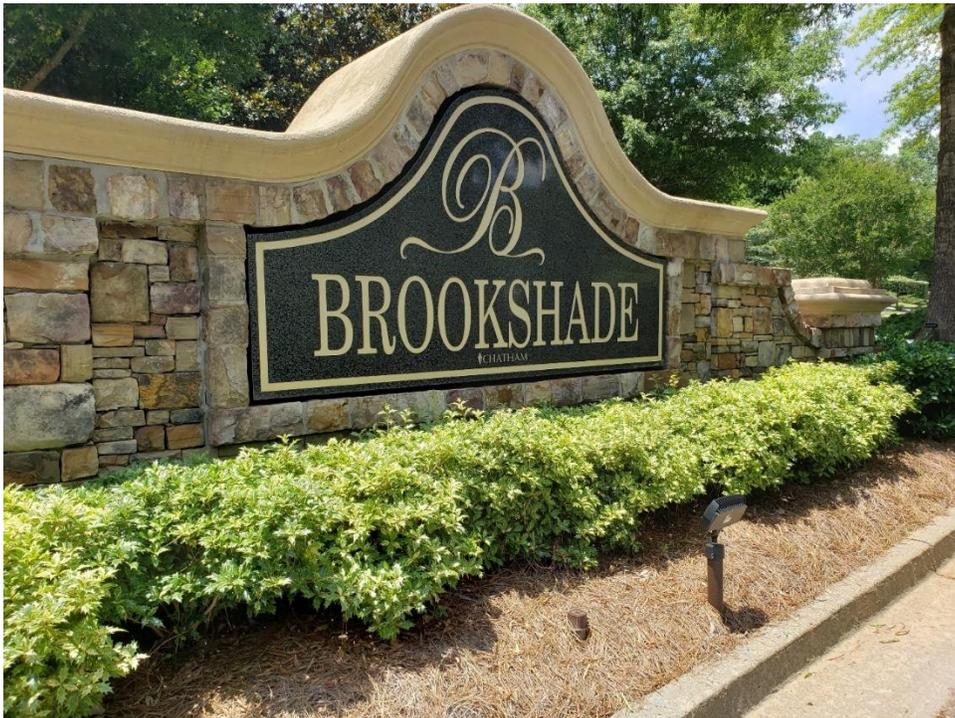
4. **Entry Monuments and Signage/Fencing** – The entry monuments and signage are located at the front entrance to the property. The monuments consist of a stone veneer monument, piers, and walls. The entry sign consists of an engraved metal sign and is located at the center island at the entry to the property. Between the stone piers is a pre-finished aluminum fence. It is our understanding that the signage and monuments have undergone maintenance, as needed, for 20+ years. From our review, the entry monuments and signage appeared to be in generally good condition and structurally sound (reference photographs 6 & 7).

6. View of entry monument and signage.

*Any mildew growth on the monuments and grout joints may be power washed as part of regular maintenance for a better appearance. It is recommended that \$10,000 be allocated for the repair, cleaning, and tuck pointing of the entry monuments and signage approximately every eight years. It is also recommended that \$3,000 be allotted for the repair, partial replacement, and painting of the common area fencing every six years. It has been requested that the budget for repair cleaning and tuck pointing of the entry monuments and signage be moved to 2030.*

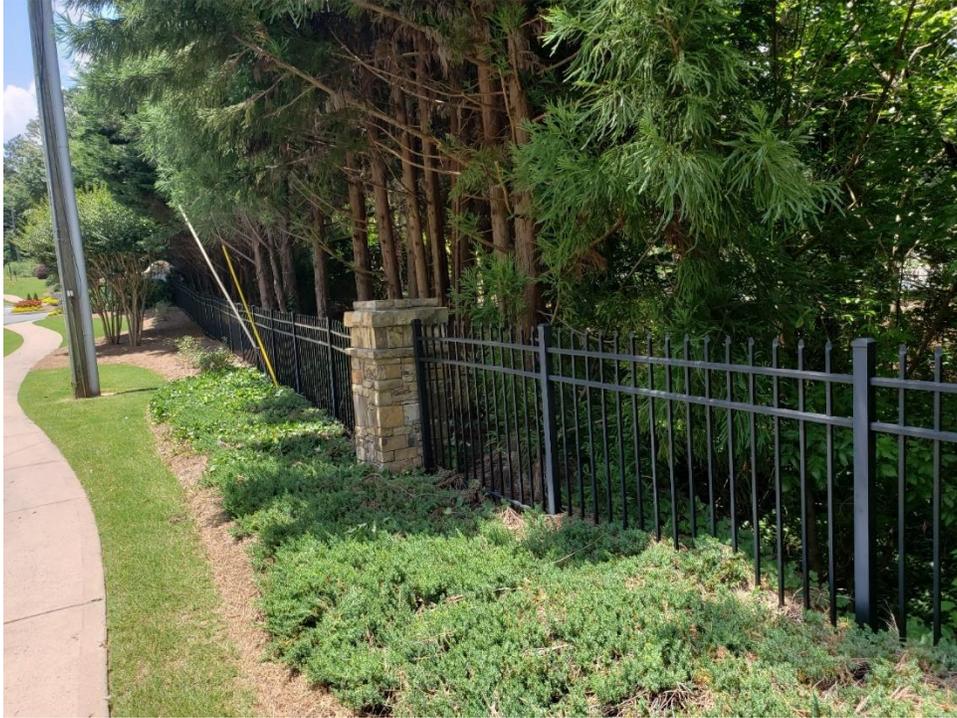
7. View of entry piers and fencing.

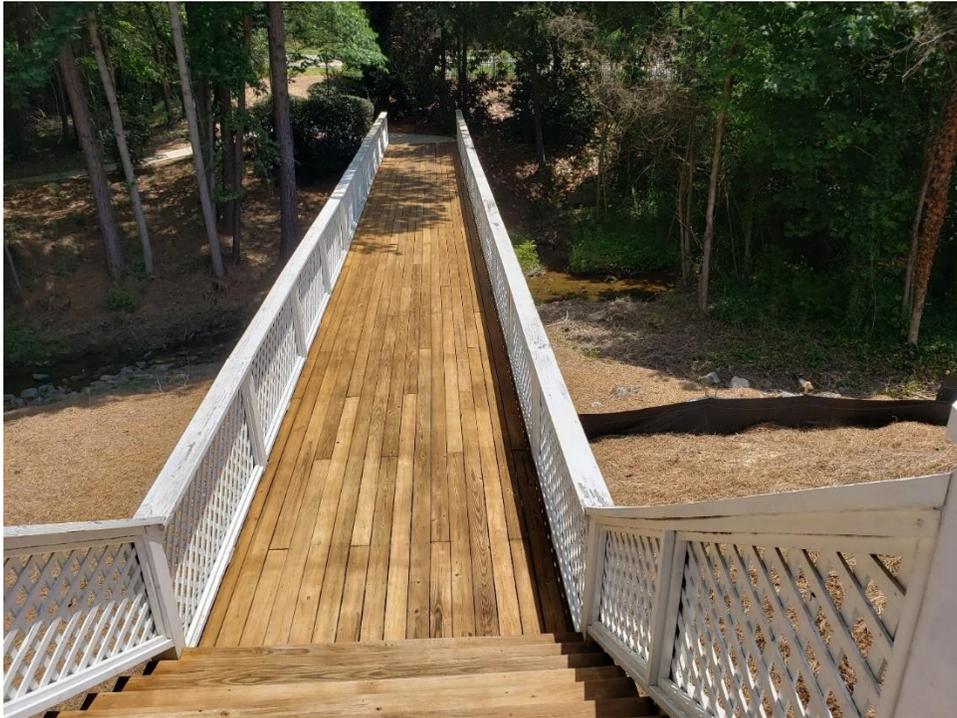
The bridges at the walking trail appeared to be in generally good condition and structurally sound; however, we did observe some chipped paint at the main entry bridge (reference photographs 8-12).

8. View of main bridge to walking trail.

*A budget of \$10,000 has been allocated for the replacement of any uprooting, damaged or diseased shrubs and trees, trimming of trees, and upgrading of the landscaping every five years. This is not designed for yearly or routine landscaping or annual flower installation. All trees that are located within 10' of a structure should be removed or monitored to prevent any damage. As requested, we have allotted a budget of \$2,500 every year for the removal and trimming of trees and maintenance at the walking trail. We have also allotted a budget for the repair, painting, and partial replacement of the bridges for approximately every eight years. A budget of \$20,000 has been allotted for the replacement of the large walking trail bridge to be completed in approximately 10 years.*

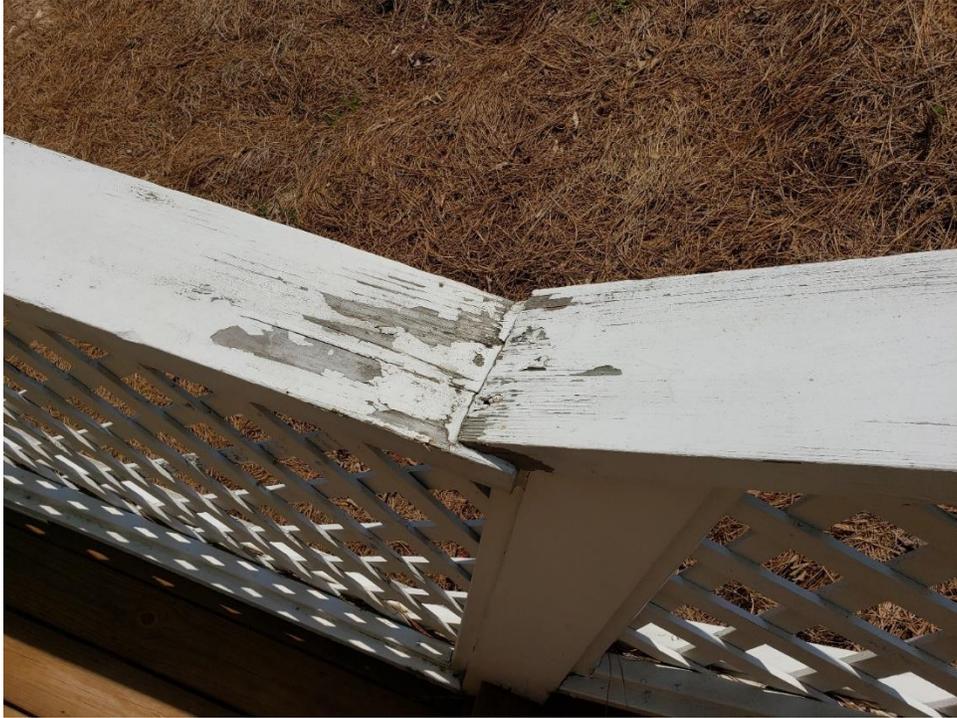
9. View of chipped paint at the main bridge railing.

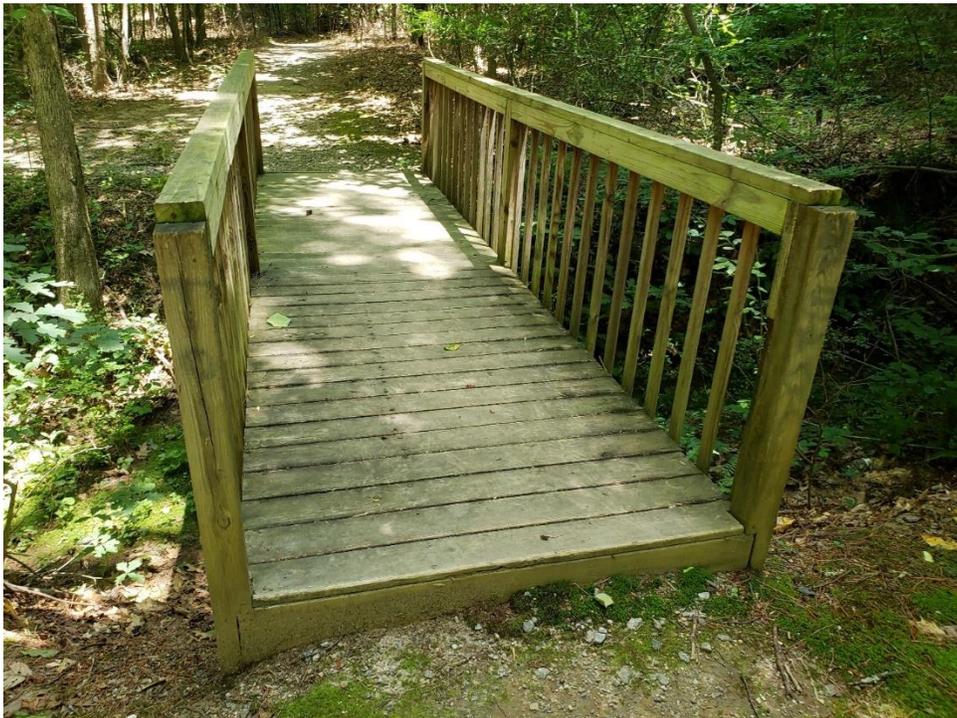
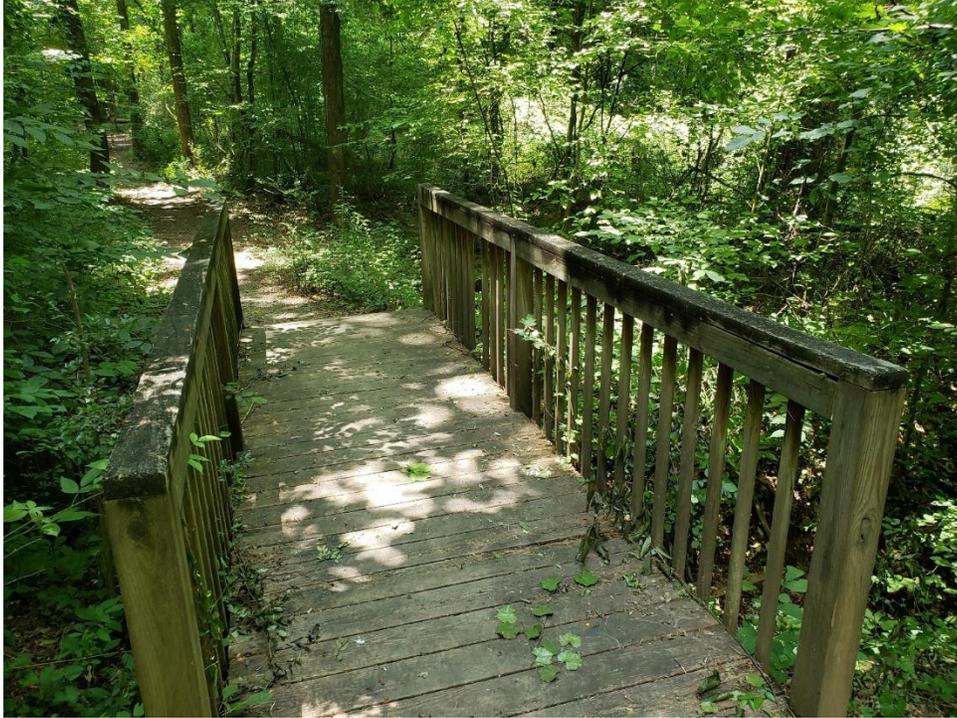
10. View of walking trail bridge.

11. View of walking trail bridge.

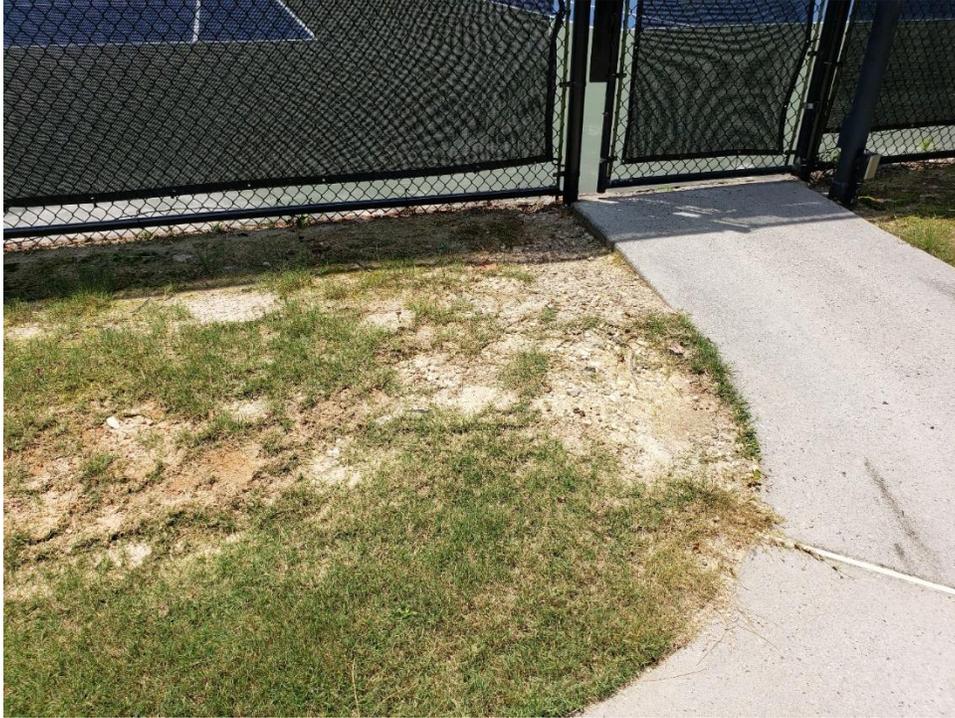
exposed soil, and minor erosion. We also observed a drain outlet structure that is blocked by accumulated silt at the beginning of the creek near the amenity area (reference photographs 13 & 14). Remediation of the erosion is necessary in order to prevent further erosion and damage to the surrounding landscape or structures. All drainage structures should be cleared to allow for proper water flow. It is our understanding that there are also 22 yard inlet structures between a few homes that are the Association's responsibility and will require maintenance in the near future.

13. View of erosion and dead grass near the tennis courts at the amenity area.

*If there are any areas that appear to have poor drainage, it is recommended that swales and river rock be installed to improve the surface flow of water, as needed. It should be noted that it is possible to install French drains in landscaped areas to further improve the drainage. A budget of \$10,000 has been allotted for the maintenance and repair of the stormwater drainage every seven years. The budget for the drainage may decrease over time as a result of proper maintenance. As requested, we have allotted a budget of \$10,000 for the repair, maintenance, and cleaning of the yard inlets, as needed, every year for ten years. The budget for the yard inlets will cover three drains per year.*

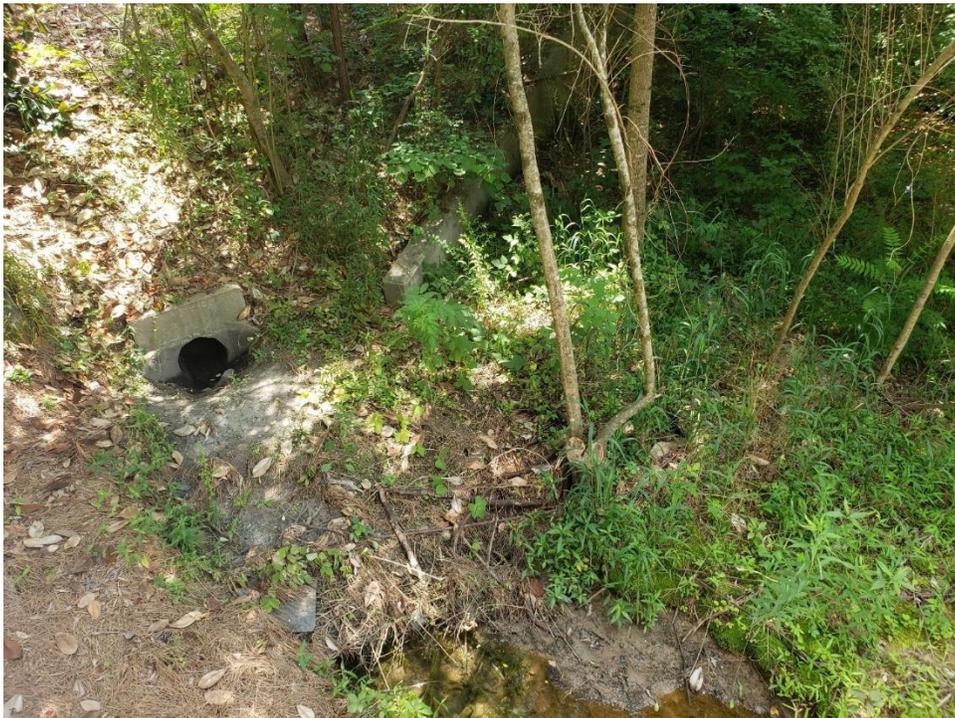
14. View of silt accumulated in front of a drain outlet structure.

*It is recommended that a budget be allotted for the removal of silt, vegetation and debris at the detention ponds every 15 years. It is also recommended that a budget be allotted for the repair and cleaning of the fencing and concrete drainage structures. The detention ponds should be monitored to determine if they are draining properly. If constructed properly, the detention ponds should drain within 48 hours after the last rain. If there is standing water at the ponds after 48 hours, the drainage at the ponds should be inspected. It is our understanding that the detention ponds will be cleared in 2020.*

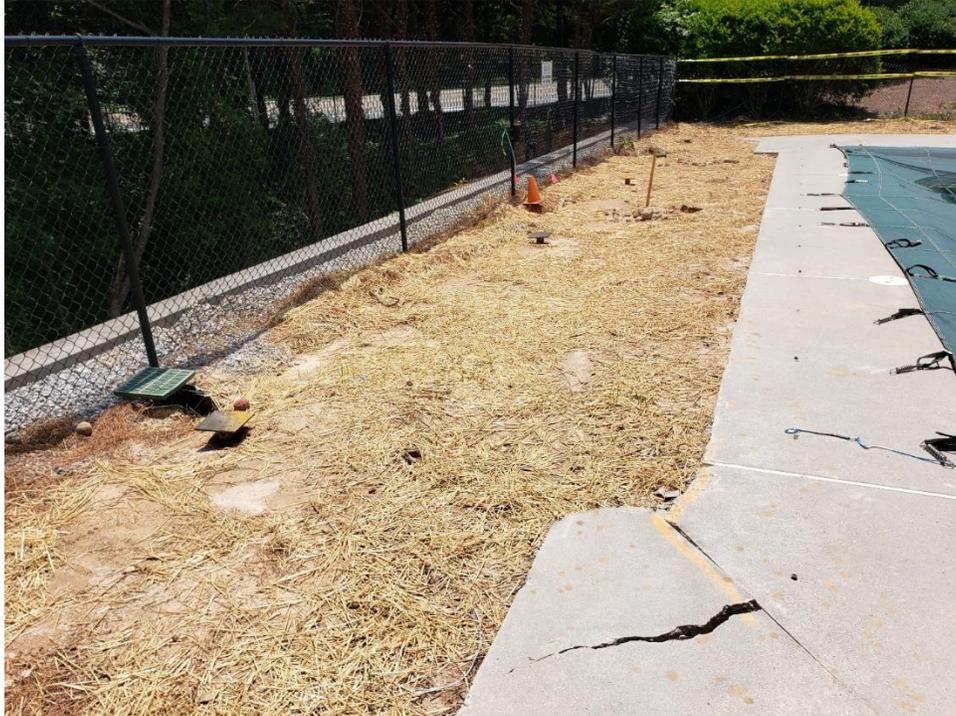
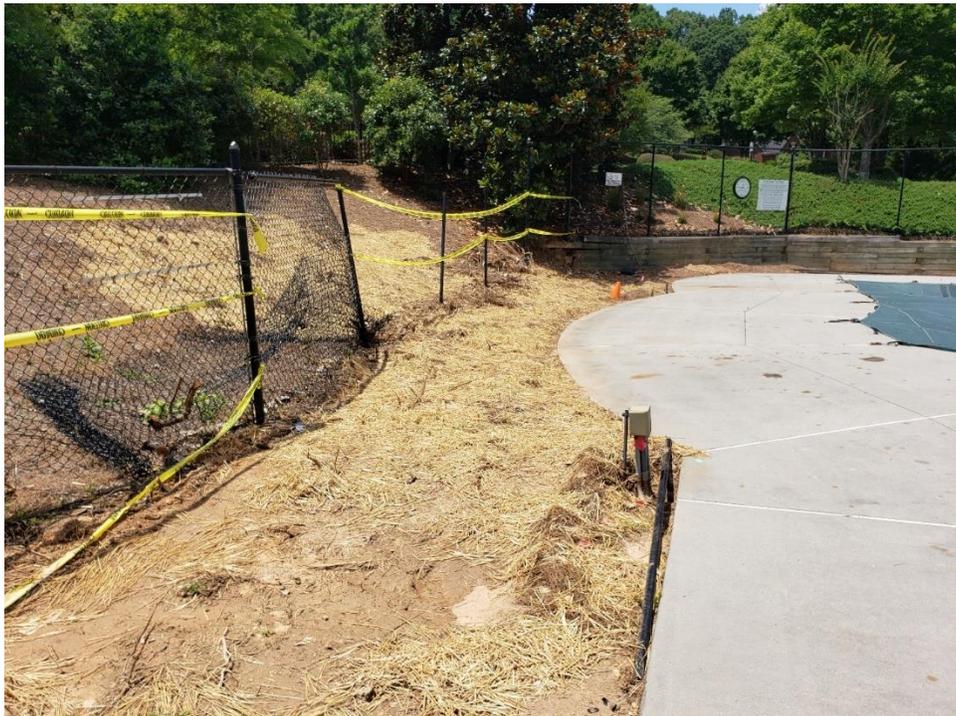
7. **Swimming Pool/Deck/Equipment** - The swimming pool consists of an in-ground concrete pool with plaster finish. The pool deck consists of a concrete slab-on-grade and is surrounded by a chain-link fence. During our review, the pool area was undergoing restoration. As a result of a building defect at the pool, the Association is having the pool stabilized and repaired. The repair is to be completed in 2019. The current stabilization remediation of the pool is not a permanent repair and the pool will have to be completely replaced within ten

years. As a result, we have allotted a one-time budget for the replacement of the swimming pool and all corresponding components to be completed within ten years. For the purpose of the reserve, we have pushed back all swimming pool and deck items to be conducted after the swimming pool is projected to be replaced. The condition of the pool cover is also poor and should be replaced this year (reference photographs 15-17).

15. View of construction around pool area.

16. View of construction around pool area.

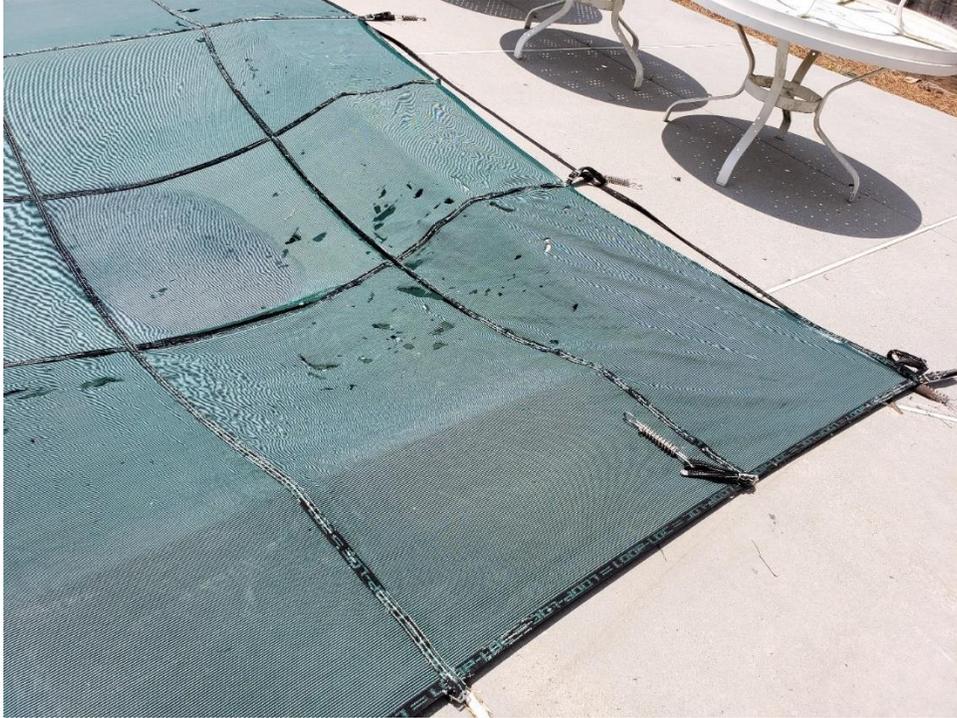
17. View of holes and tearing of the pool cover.

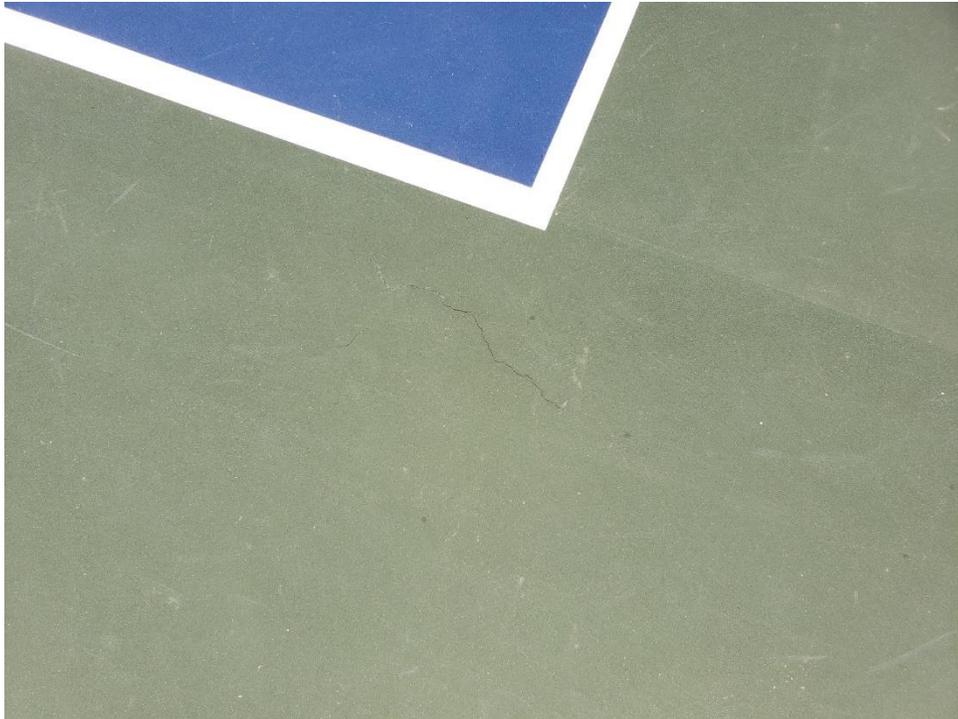
- 8. **Tennis Courts** – There are two tennis courts at the amenity area. The tennis courts at the property consist of two hard-surfaced, lighted tennis courts surrounded by a metal chain link fence. There are small benches located at each side of the tennis court area. It is our understanding that the tennis courts were resurfaced in 2018. From our review, the tennis courts appeared to be in generally good condition with only minor linear cracks observed (reference photographs 18 & 19). The linear cracks appear to be the result of normal expansion and contraction of the tennis court surface materials.

19. View of typical small linear crack at the tennis court.

<i>Tennis Courts 1 &amp; 2 – Resurface (Crack Repair).....</i>	<i>Every 4-5 years</i>
--	------------------------

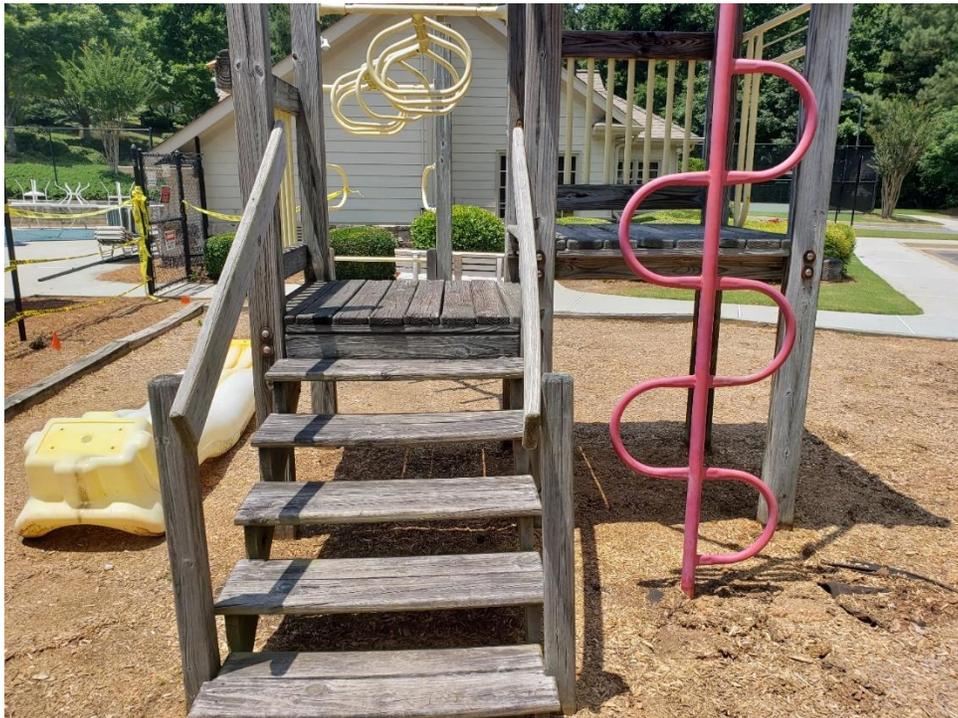
9. **Playground** – The playground equipment is located at the amenity area, to the left of the club house. The playground equipment consists of a wood-framed structure with polyethylene equipment and slides. From our review, the playground equipment appears to be reaching the end of its useful life and should be replaced in the near future (reference photographs 20 & 21).

20. View of the playground equipment.

*It is recommended that \$2,000 be allotted for the repair and partial replacement of the playground equipment every eight years. It is also recommended that \$20,000 be allotted for the replacement of the playground equipment every 20 years.*

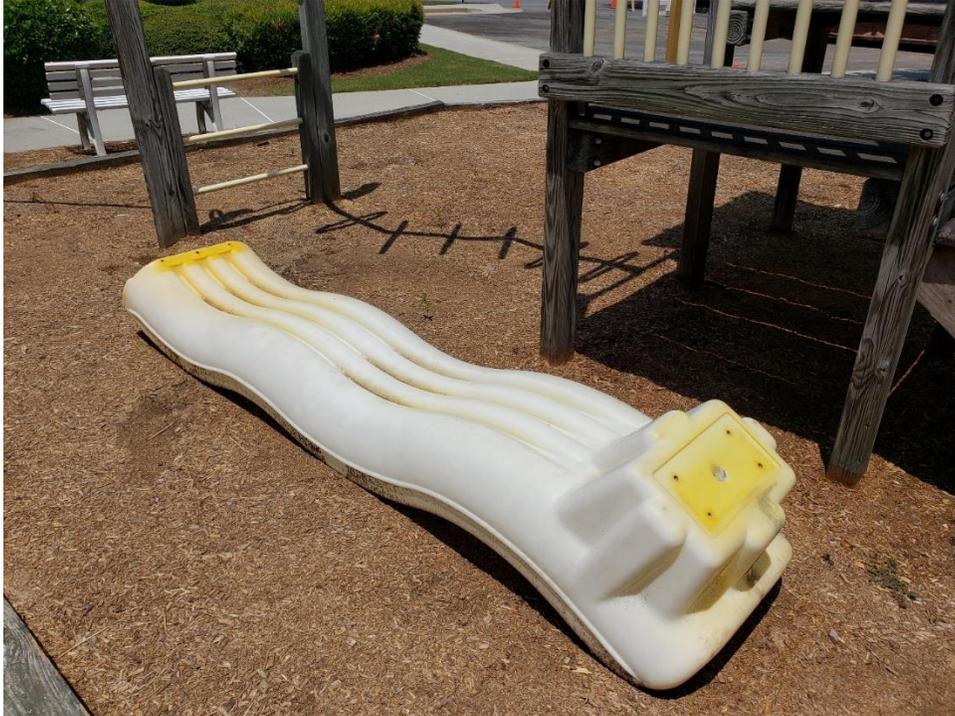
21. View of slide that is not attached to the playground equipment.

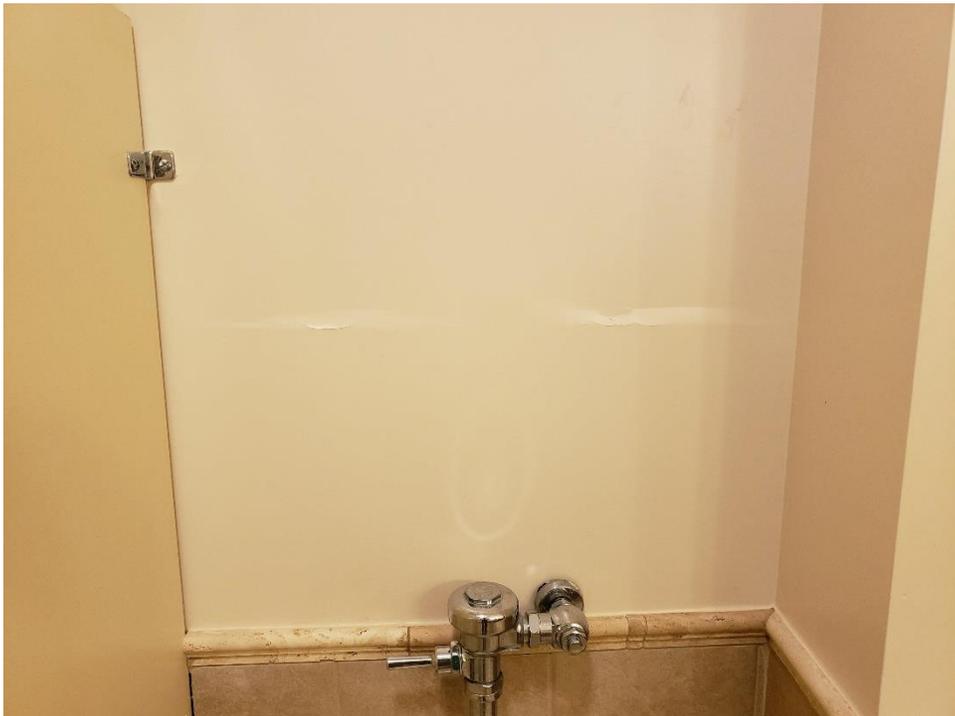
Based on our review, the clubhouse appeared to be in generally good condition and well maintained; however, we did observe damage at the men’s restroom wall above the urinal (reference photographs 22-26). It is difficult to determine the cause of the damage at the wall and may require some additional investigation to determine if it is a structural concern. It is our understanding that the men’s urinal does not work and will need to be repaired in the near future.

26. View of damaged wall at the men's restroom above the urinal.

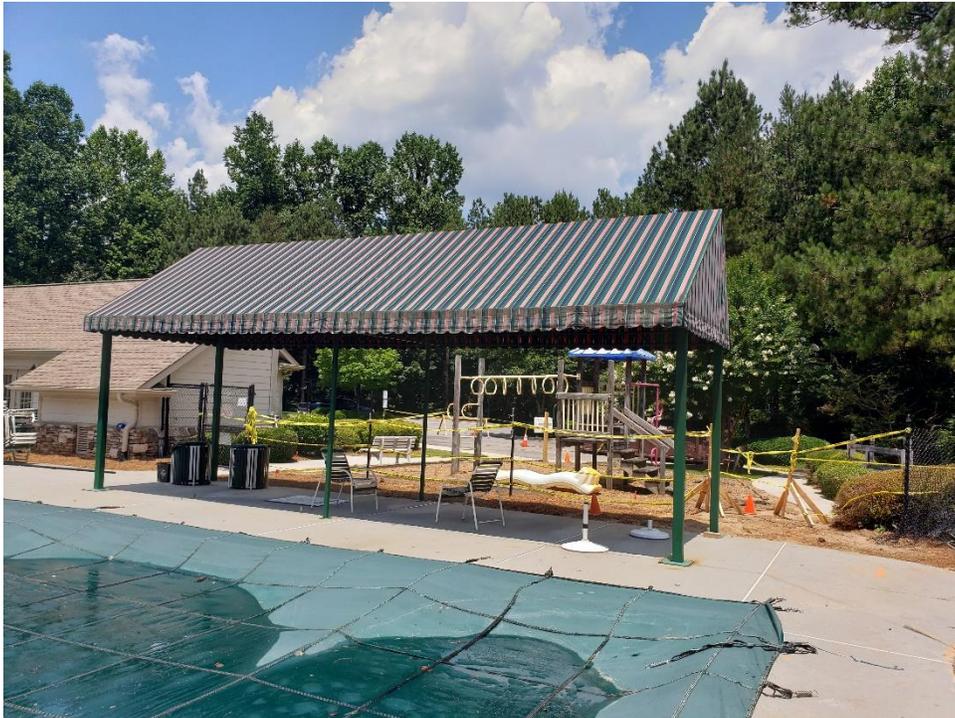
At the side of the clubhouse, on the pool deck, is a metal framed pavilion with a cloth fabric roof. From our review, the pavilion structure appears to be structural sound and in generally good condition with no remedial work required at this time (reference photograph 27).

27. View of pool pavilion structure.
